Manhole Inspection Summary

Manhole # S35Y1_030MH

Insp Date: **11/19/07 10:15 AM**

Location Address: **18 W Talbott St**

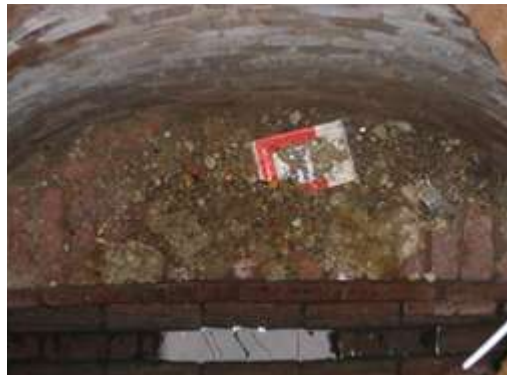
Defect 2

Condition: ☐ Sound ☐ Cracked ☐ Root Intrusion ☐ Deteriorated ☐ Leaks ☒ **Debris**

Debris on bench

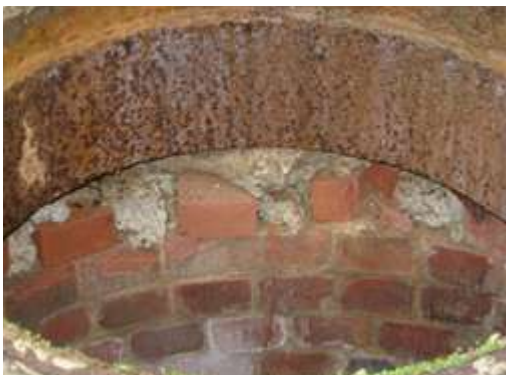
Defect 1

Condition: ☐ Sound ☐ Cracked ☐ Root Intrusion ☒ **Loose Brick** ☐ Deteriorated

Loose bricks in chimney/frame offset

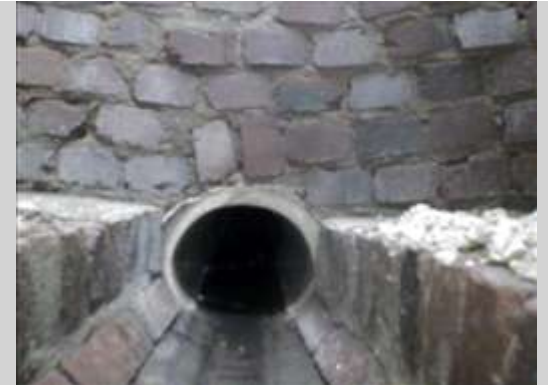
12 O'Clock Outflow

8 in. Circular Gravity Sewer
Pipe Out @ 12 O'Clock

Pipe Height: **8.4** (in.) Rod and Bar (Angled)
Pipe Material: **Clay** ☐ Pipe Lined
Invert Depth: **6.60** (ft.) Flow Characteristics: **None**
Deposits: ☒ None ☐ Mud ☐ Sludge ☐ Debris ☐ Grease
Silt Depth: (in.) Deposits Extent:
Infiltration: **None** Pipe Seal Cond: **Sound**

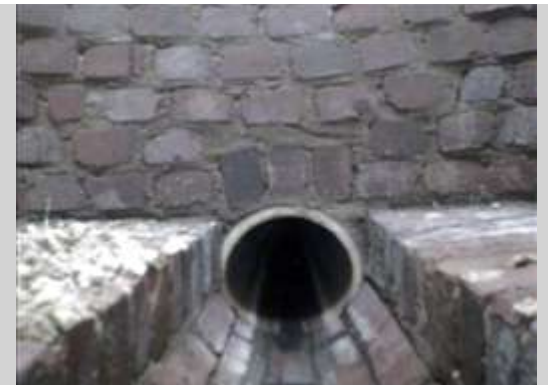
6 O'Clock Inflow

8 in. Circular Gravity Sewer
Pipe In @ 6 O'Clock

Pipe Height: **8.4** (in.) Rod and Bar (Angled)
Pipe Material: **Clay** ☐ Pipe Lined
Invert Depth: **6.50** (ft.) Flow Characteristics: **None**
Deposits: ☒ None ☐ Mud ☐ Sludge ☐ Debris ☐ Grease
Silt Depth: (in.) Deposits Extent:
Infiltration: **None** Pipe Seal Cond: **Sound**
